# PRI Construction Materials Technologies LLC

## Laboratory Test Report

**Product Name:** Aircrete Cladding 2"

**Test Methods:** ASTM E564 Shear Resistance

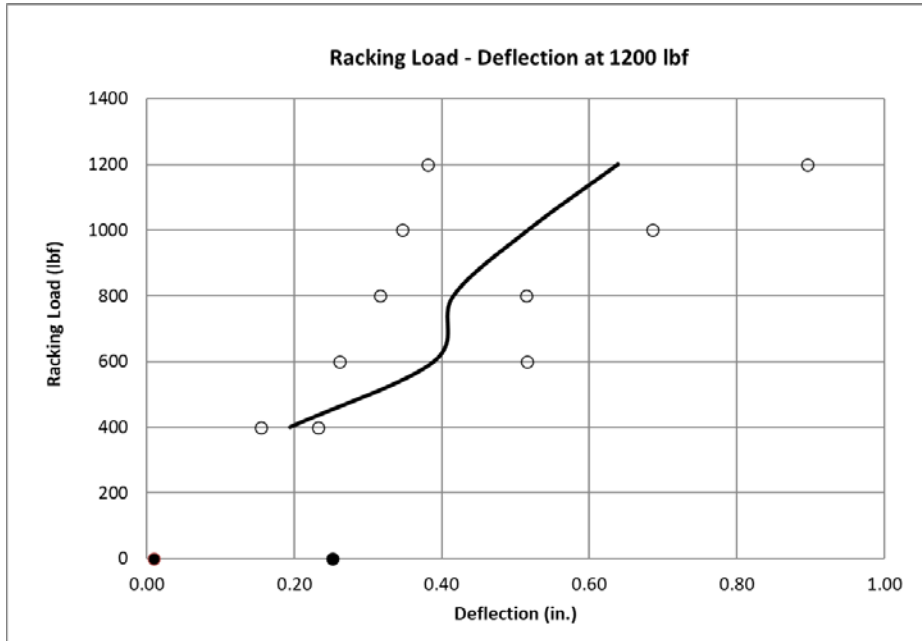
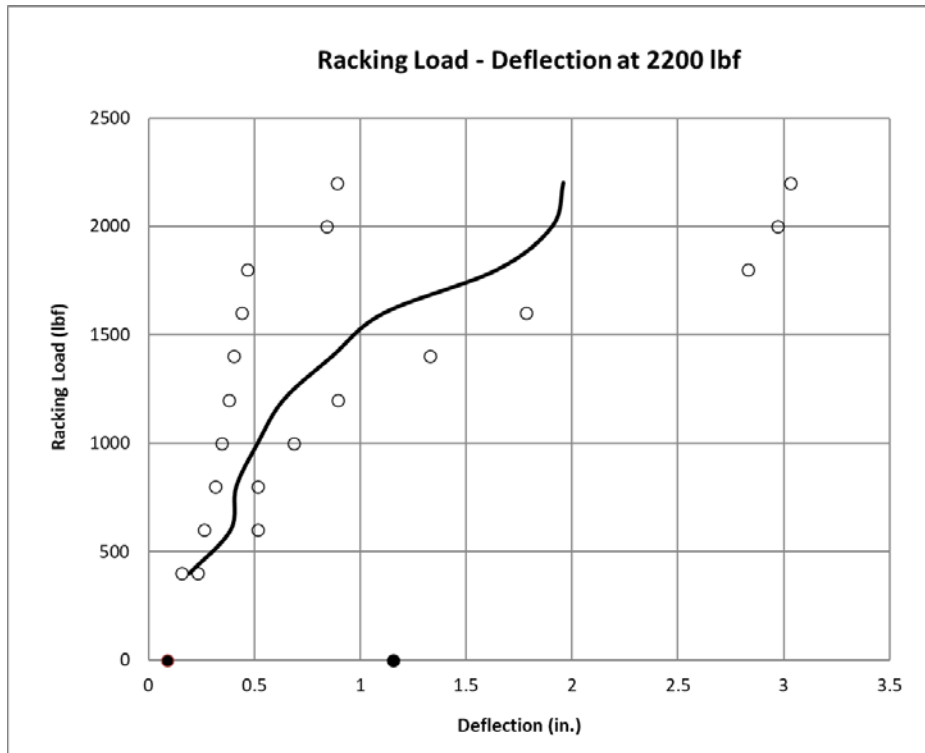
### Load-Deflection Charts – Specimens 1-2

Indicated below are deflections and permanent sets at 1200 lb<sub>f</sub>, and 2200lb<sub>f</sub>, as well as the maximum shear loads obtained from testing. The entire Load-Deflection data for individual specimens are contained in Appendix A.

Load	Specimen 1	Specimen 2	Average
0	-	-	-
300	-	-	-
0	-	-	-
400	0.16	0.23	0.19
600	0.26	0.52	0.39
800	0.32	0.52	0.42
1000	0.35	0.69	0.52
1200	0.38	0.90	0.64
0	0.01	0.25	0.12
1400	0.40	1.33	0.87
1600	0.44	1.78	1.11
1800	0.47	2.83	1.65
2000	0.84	2.97	1.91
2200	0.89	3.03	1.96
0	0.09	1.16	0.62
2400	0.96	3.02	1.99
2600	0.99	3.08	2.04
2800	1.04	3.11	2.07
3000	1.09	3.16	2.12
3200	1.17	3.18	2.17
3400	1.22	3.23	2.22
3600	1.27	3.29	2.28
3800	Fail	3.32	3.32
4000	-	3.39	3.39
4200	-	Fail	-

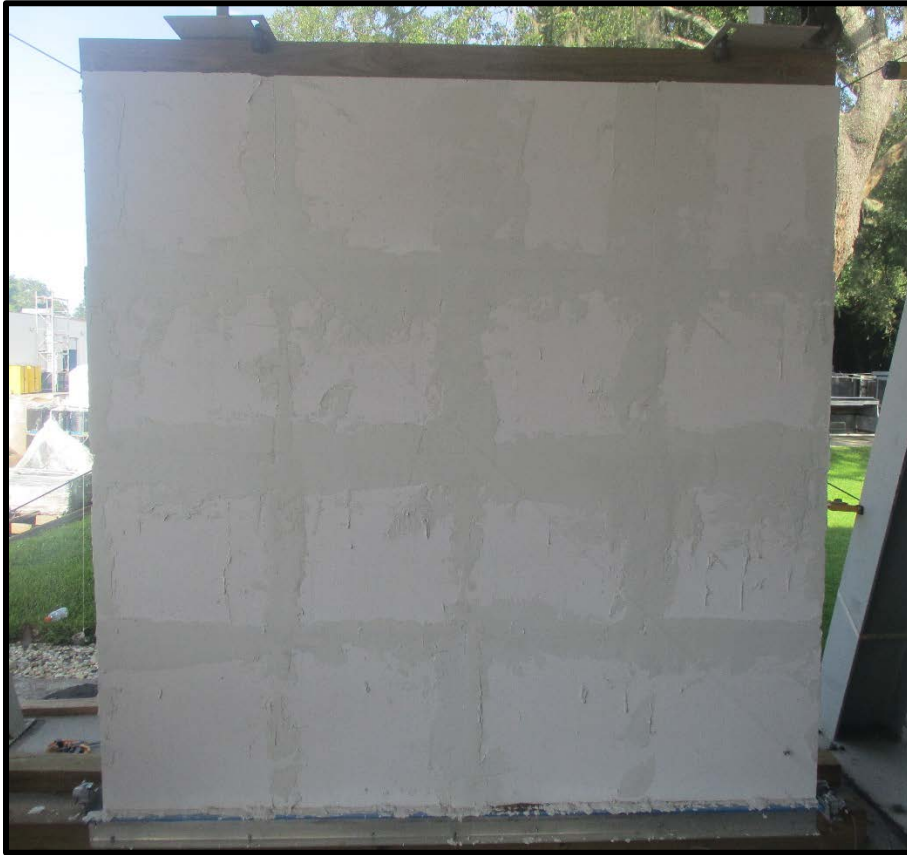
**Photographs**  
**Assembly 1 in Test Apparatus (Typical)**

Shear load application and test setup was in accordance with ASTM E564. Specimen sill plates were bolted and secured to an immobile timber. Evaluation of the sill connection was omitted. Loading was applied at the timber bolted to the top plate at a rate of 400 lb<sub>f</sub>/min. Lateral guides were used to limit out-of-plane deflection. Deflection sensors were positioned in accordance with ASTM E564.

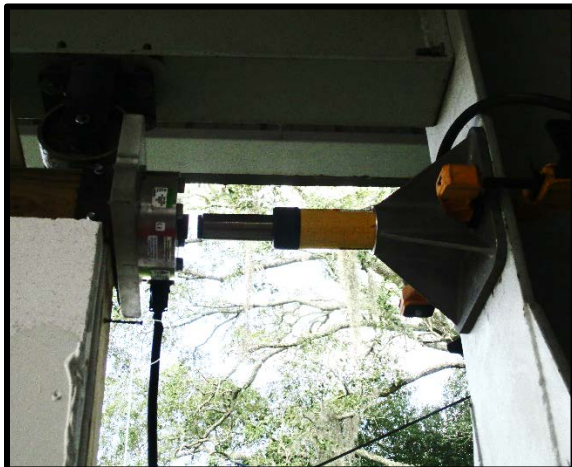
**Load Cell**

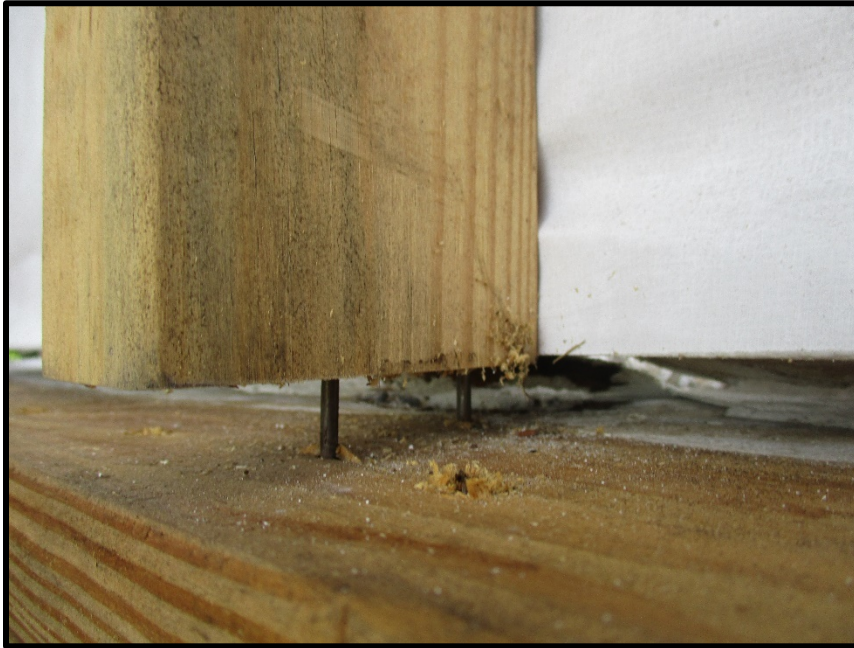
**Specimen 1 Failure (Stud Fastener Withdrawal)**

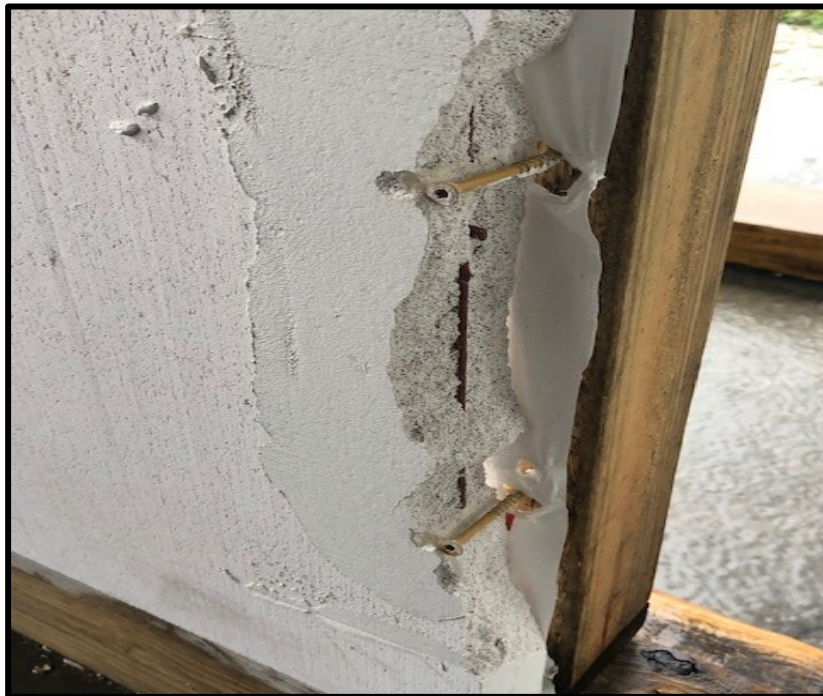
**Specimen 2 Failure (Corner Rupture)**

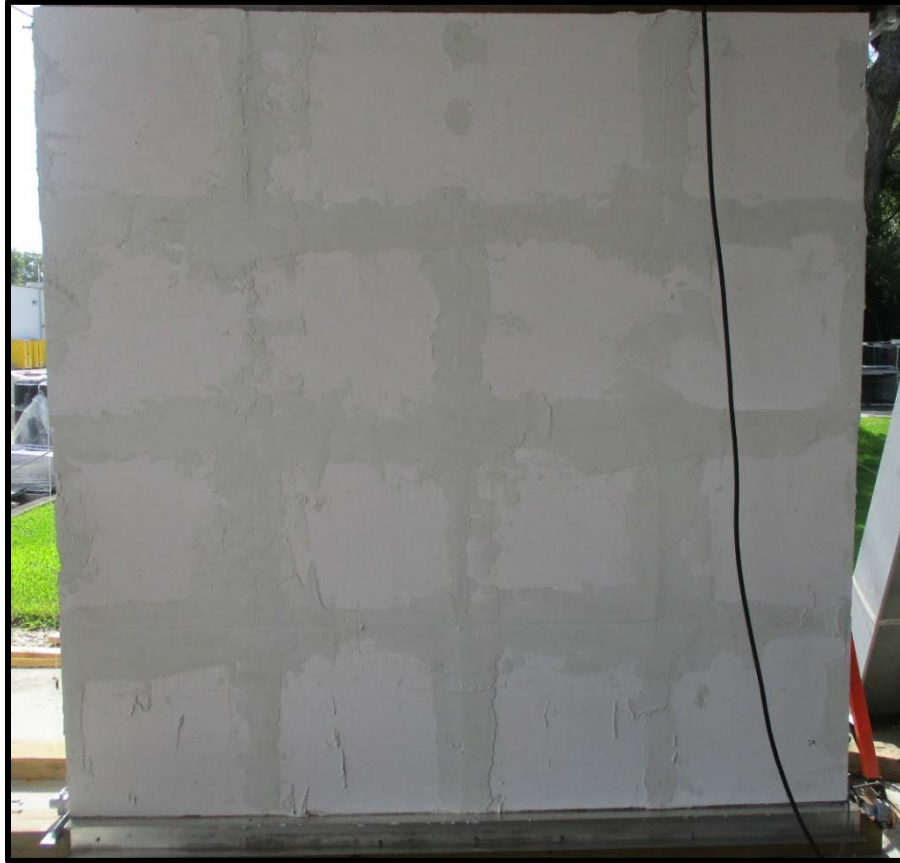
**Assembly 2 After Testing - Damage Occurred on End Panels Only at Anchor Locations (Typical)**
